Intel[®] Mobile Pentium[®] II Processor Specification Update

Release Date: November 2000

Order Number: 243887-026

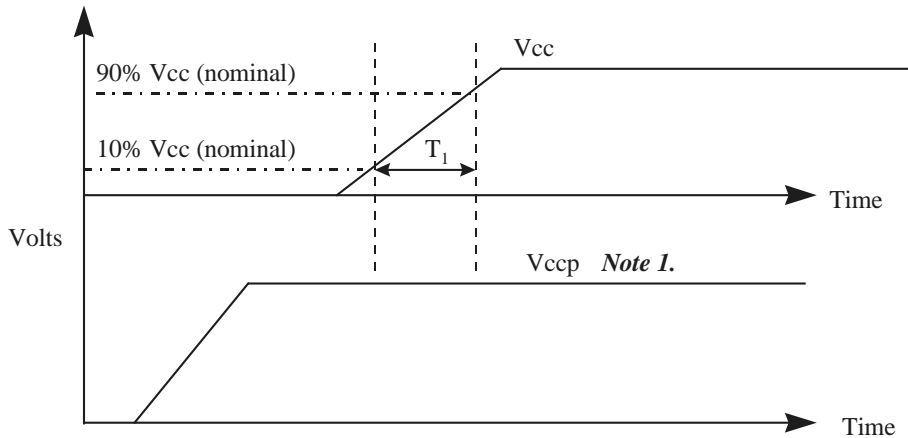
Figure 1. V_{CC}/V_{CCP} Timing Requirements (Mobile)

Problem: The processor uses the PWRGOOD signal to ensure that no voltage sequencing issues arise; no pin assertions should cause the processor to change its behavior until this signal is asserted, when all power supplies and clocks to the processor are valid and stable. However, if V_{CC} ramps up before V_{CCP} , it will cause the processor to enter an invalid state.

Implication: If this erratum occurs, the system may boot normally however, the L2 cache may not be initialized.

Workaround: For Mobile Pentium II processors, ensure that V_{CC} ramps after or with the L2 cache IO voltage (V_{CCP}). If V_{CCP} ramps after the V_{CC} , a delay circuit can be placed on the core V_{CC} to ensure that V_{CC} ramps at the same time or after V_{CCP} as shown below in Figure 1.

Symbol	Parameter	Min	Max	Notes
T_1	V_{CC} Ramp Time	200 μ Sec		Measured between 10% V_{CC} (nom) to 90% V_{CC} (nom)
Note 1: V_{CCP} must be greater than V_{CC} during the interval in which V_{CC} rises from 20% V_{CC} to 80% V_{CC} .

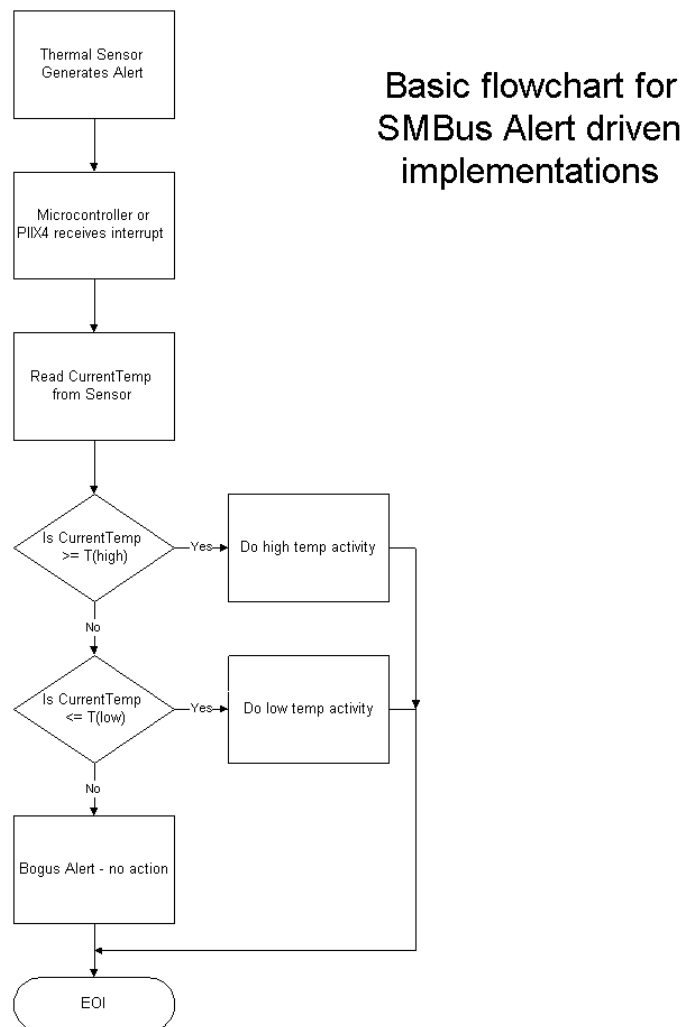
Figure 2. Workaround Flowchart: SMBALERT#-Driven System

Under the conditions described below, the thermal sensor incorrectly generates the SMBALERT# interrupt. All of the following conditions must be met to trigger a false interrupt:

1. Before servicing an interrupt from the thermal sensor, read and compare the processor thermal reading with the threshold limits (T_{HIGH} or T_{LOW}). Figures 2 and 3 provide basic flowcharts for the implementation of this workaround in an interrupt driven system.
2. If the firmware implemented polls the Status Register only, then before taking any action, re-read the temperature register and do a comparison with the alarm threshold limits (T_{HIGH} or T_{LOW}) to determine if the value is actually still within the temperature window.

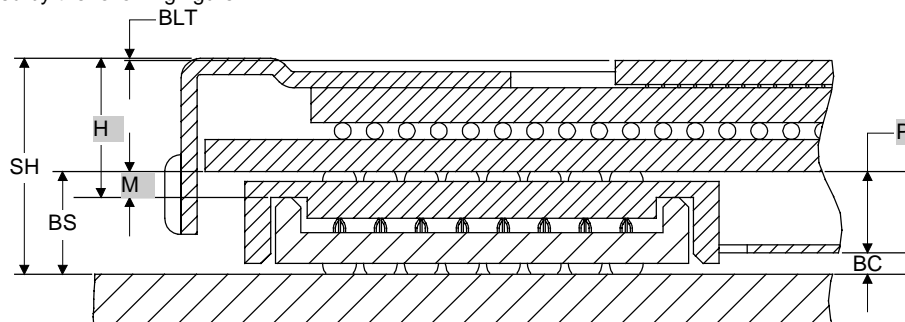
Figure 5.6. Cross Sectional View with Vertical Dimensions

B1. Mislabeled Vertical Dimension Parameters

Figure 5.6 in the *Mobile Pentium® II Processor at 233 MHz, 266 MHz, and 300 MHz* datasheet should be replaced by the following figure:

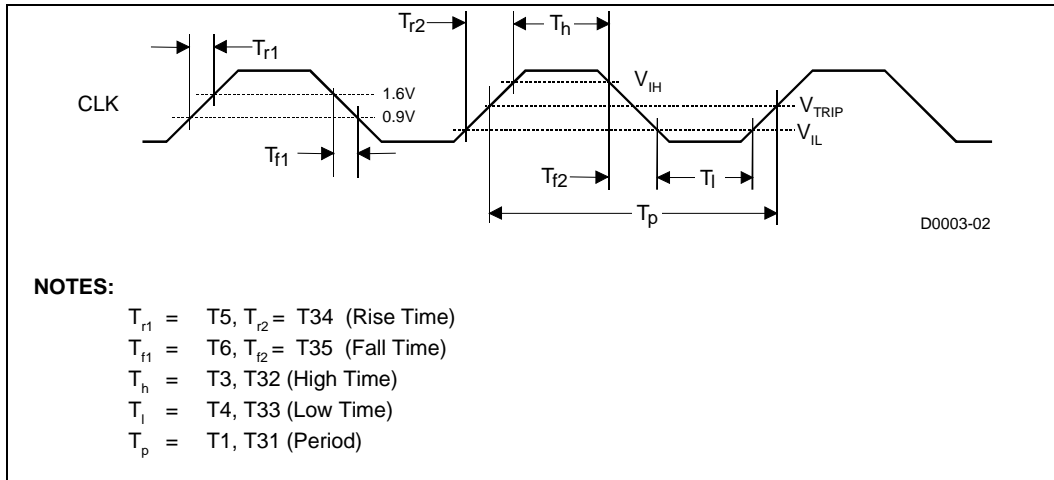
Figure 3.3 Generic Clock Waveform

B14. Generic Clock Waveform Figure

Figure 3.3 in *Mobile Pentium® II Processor in Mini-Cartridge Package at 366 MHz, 333 MHz, 300PE MHz, and 266PE MHz* datasheet (Order Number 245108), and the *Mobile Pentium® II Processor in BGA Package at 366 MHz, 333 MHz, 300PE MHz, and 266PE MHz* datasheet (Order Number 245106) has been updated. The following figure is to replace the ones in the above documents.

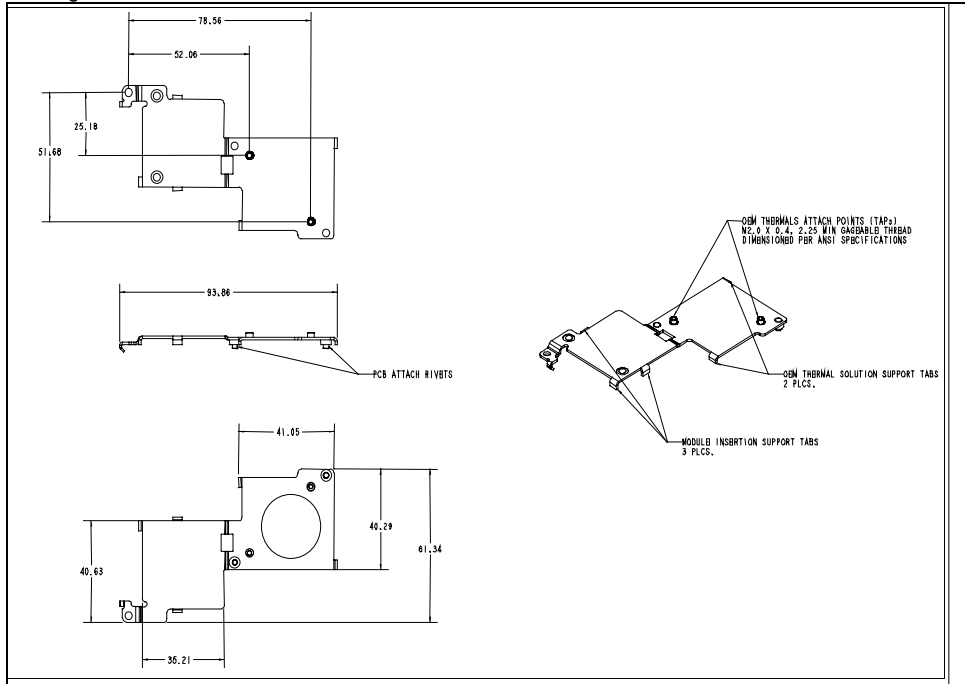
Figure 1. TAP Gageable Thread Clarification

OEM Thermal Attach Points (TAPs) M2.0 x 0.4, 2.25 min gageable thread dimensioned per ANSI specification.
